**REPORT:** FE-45-97

**RAILROAD:** Union Pacific Railroad Company (UP)

**LOCATION:** Boise, Idaho

**DATE, TIME:** Dec. 26, 1997, 5:45 p.m., MST

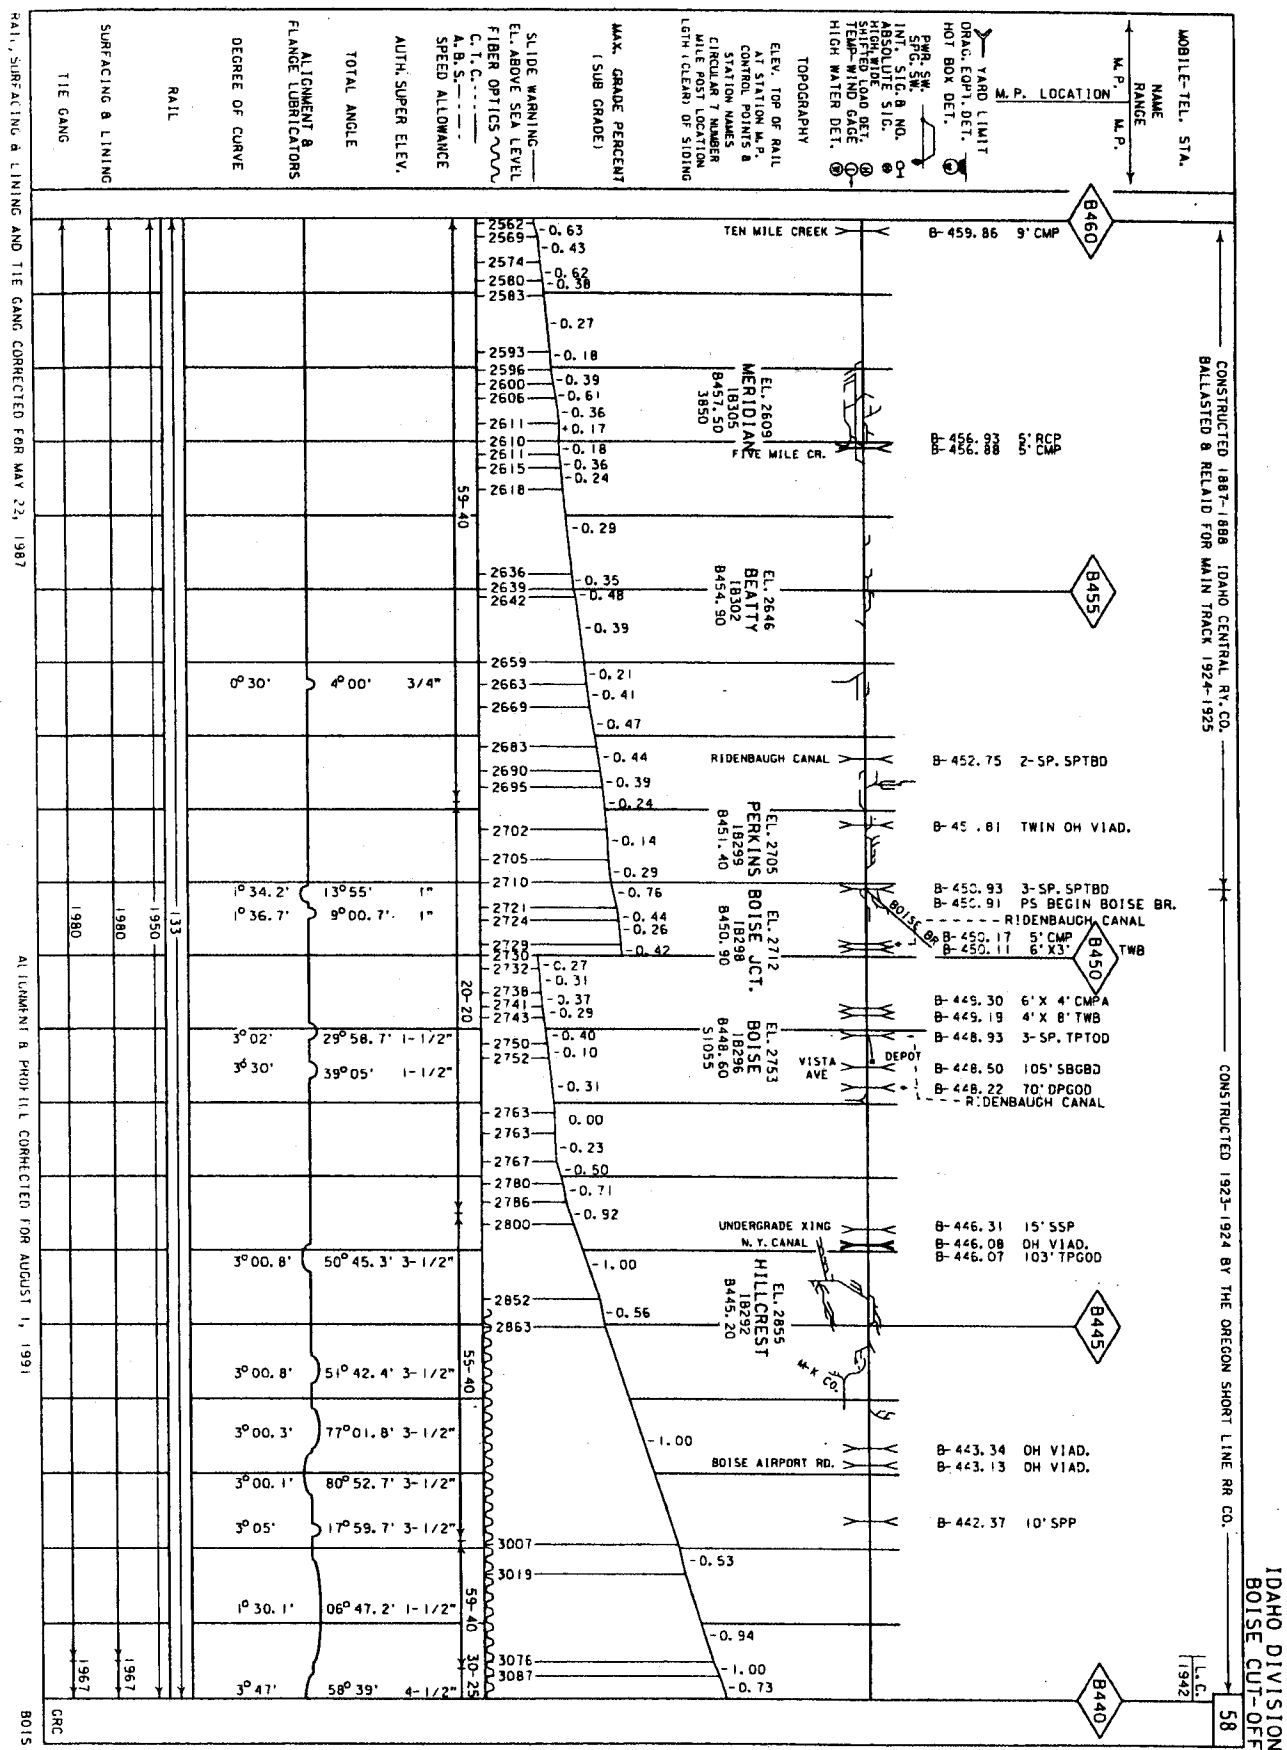
***(Please see the attached diagram of the Boise Subdivision to better visualize the accident scene and the chain of events that led up to the fatality.)***
